**USAAVLABS TECHNICAL REPORT 70-66**

MODE OF FAILURE INVESTIGATIONS
OF HELICOPTER TRANSMISSIONS

CONTRACT DAAJ02-69-C-0061
BELL HELICOPTER COMPANY
FORT WORTH, TEXAS

This report presents the results of a program of review and analysis of failed parts rejected during UH-1 and CH-47 transmission overhaul at ARADMAC. The program was conducted to identify the modes of failure and to reveal areas requiring additional research or development to improve engineering design capability.

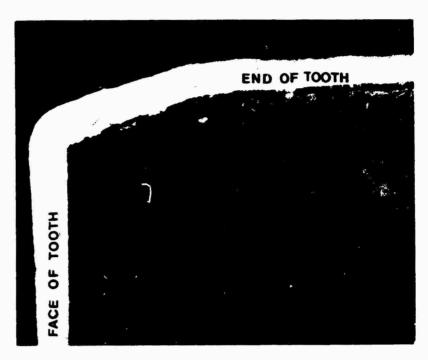
Figure 32. Profile Section Showing Chamfer at End of Ring Gear Tooth (P/N 204-040-331-5).

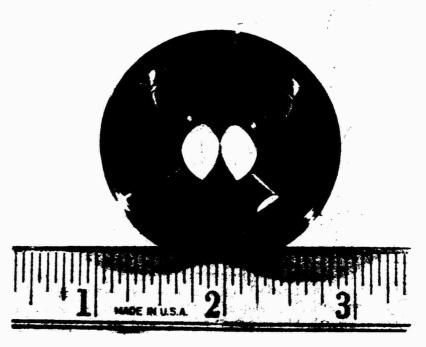
Figure 40. Cracked Planetary Washer (P/N 204-040-789-1).

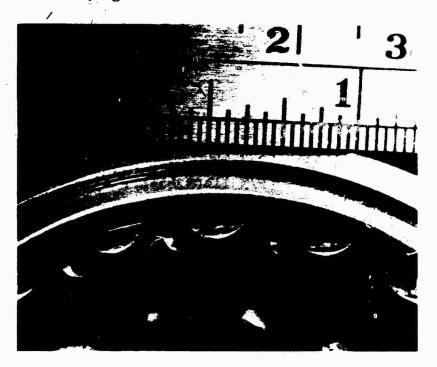
Items No. 6A and 14A - Bearings (P/N 114DS249-1 and 114DS265-1) had a 40.6% and a 43.8% replacement rate, respectively, because of wear on the ends of the rollers (Figures 57 and 58). Wear on

Figure 57. Roller Bearing End Wear (P/N 114DS249-1).

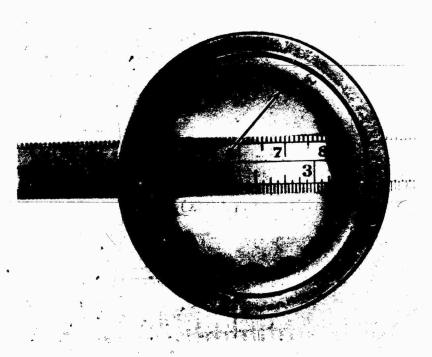
Figure 58. Roller Bearing End Wear (P/N 114DS265-1).

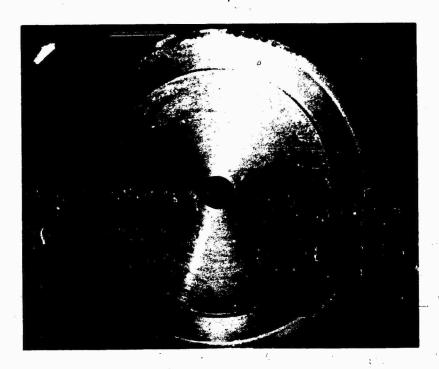
Figure 77. Wear and Cracking on Retainer (P/N 114D2184-1).

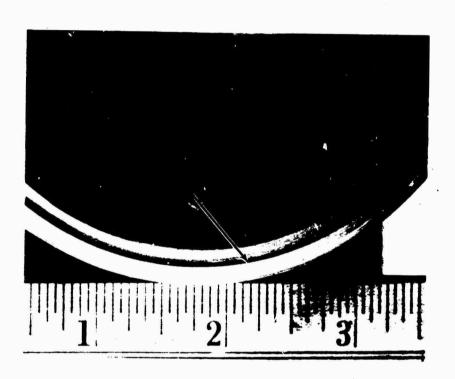
Item No. 9C - Lubricator (P/N 114D5063-1). Three were replaced because of wear (Figure 81). This part acts as a spacer and is clamped axially between two bearings (P/N's 114DS543-1 and 114DS544-1) on the aft output shaft. The wear results from the outer rings of the bearings spinning in the support assembly (P/N 114D5043-1). Length of the part shown is 0.020 inch below minimum drawing dimension, and length of the three parts ranged from 0.008 inch to 0.056 inch below drawing minimum.

Figure 81. Wear on Face of Retainer (P/N 114D5063-1).

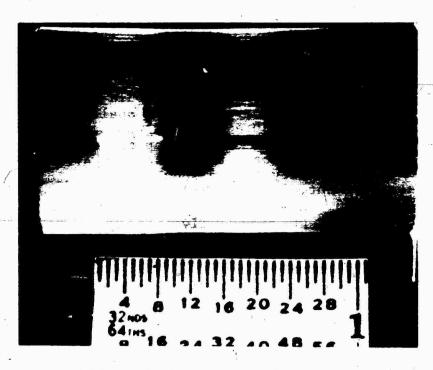
Figure 102. Section From Bearing Outer Ring Showing Surface Initiated Failure (P/N 114DS143-1).
